**CWA COMPLIANCE EVALUATION INSPECTION REPORT
U.S. ENVIRONMENTAL PROTECTION AGENCY, REGION 5**

Purpose: Compliance Evaluation Inspection

Facility: Calf Land, LLC.

Date of Inspection: October 31, 2013

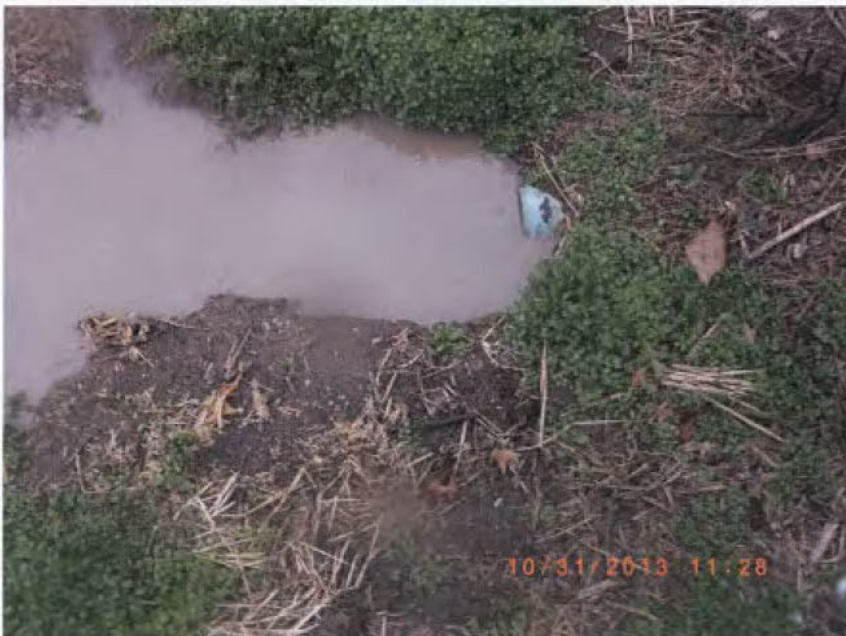
71: IMGP0593

Description: Green pipe under central access road flowing into grassed swale on west side of central access road.

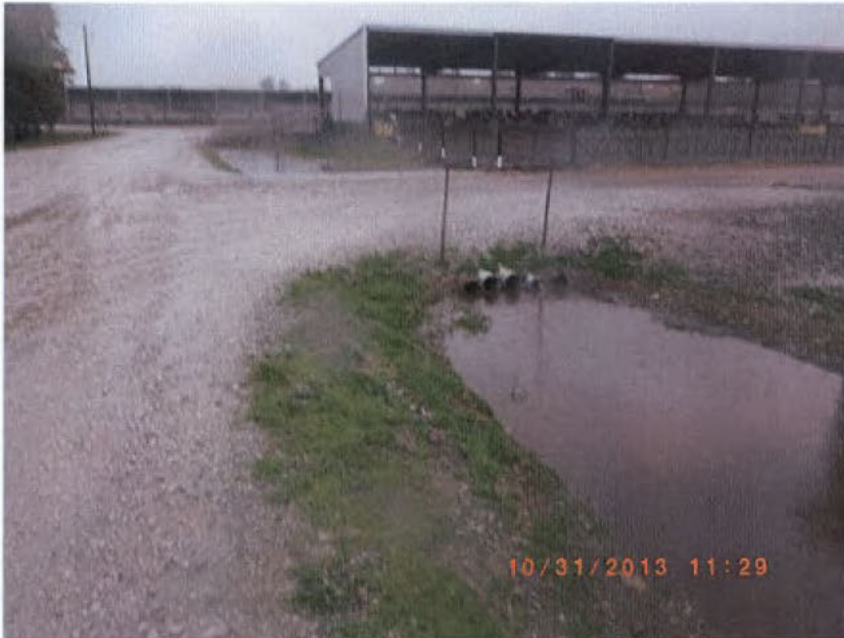
72: IMGP0594

Description: Flow of runoff from pen areas through pipes under road between pen 5 and pen 4.

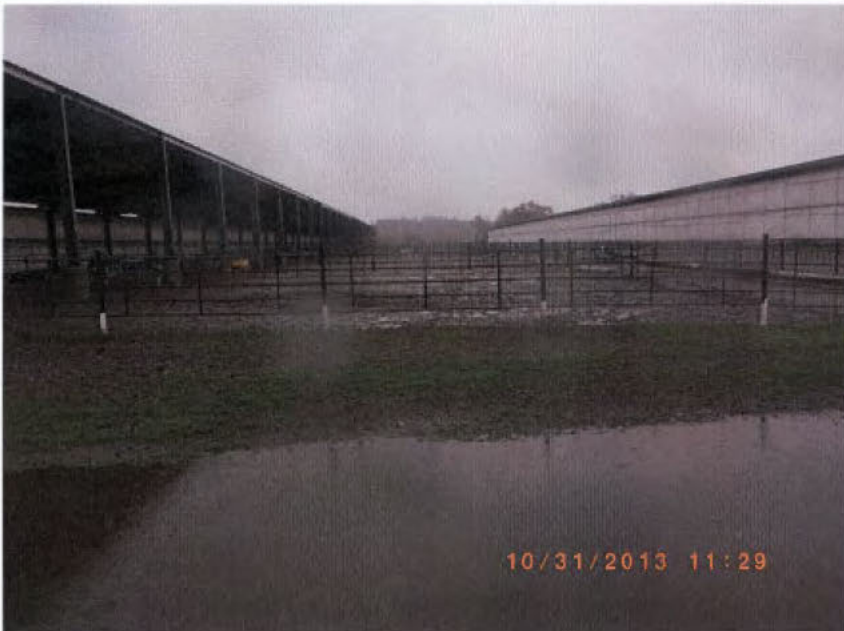
73: IMGP0595

Description: Pen 4.

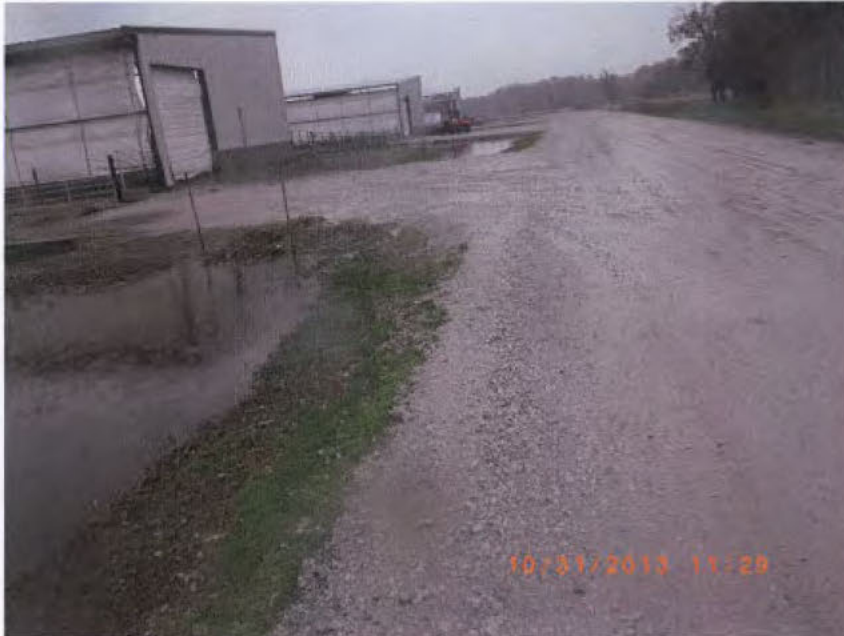
74: IMGP0596

Description: Flow of runoff from pen areas through pipes under road between pen 4 and pen 3.

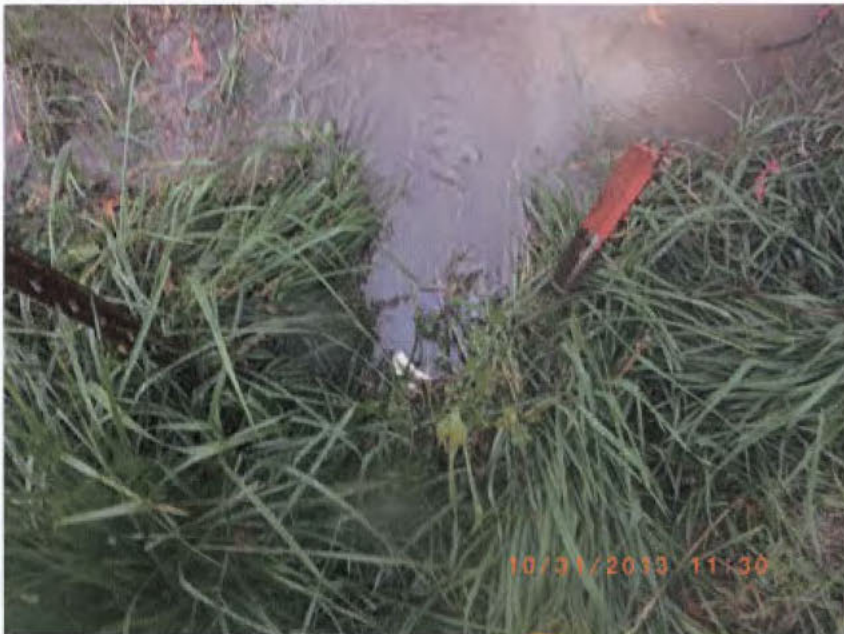
75: IMGP0597

Description: Close up of water entering pipes under road between pen 4 and pen 3.

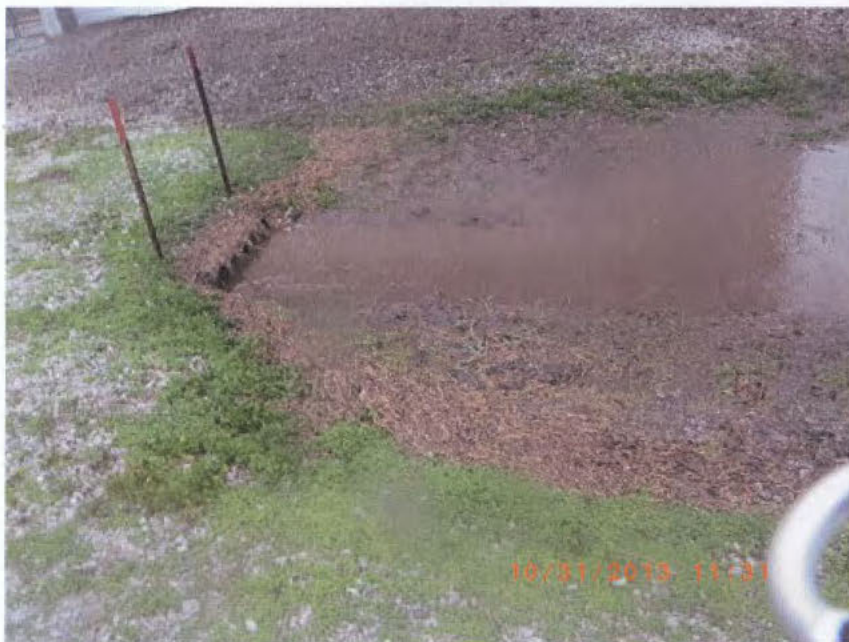
76: IMGP0598

Description: Flow out of pipes under road between pen 4 and pen 3.

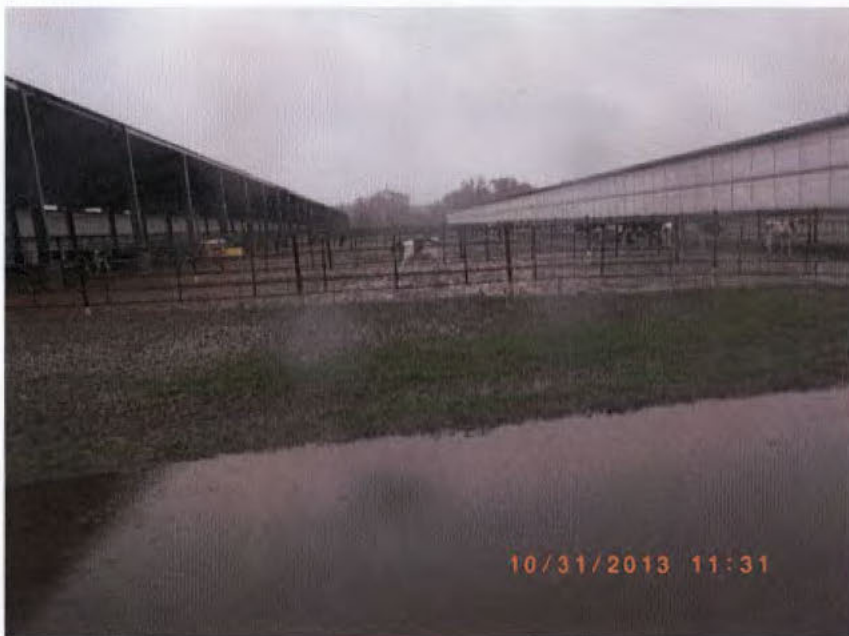
77: IMGP0599

Description: Pen 3.

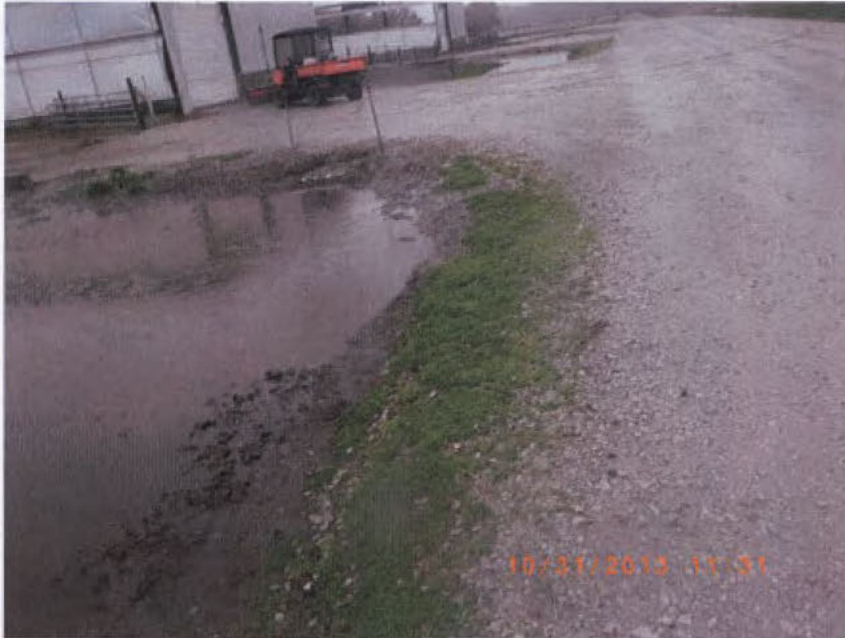
78: IMGP0600

Description: Flow of water into pipes under road between pen 3 and pen 2.

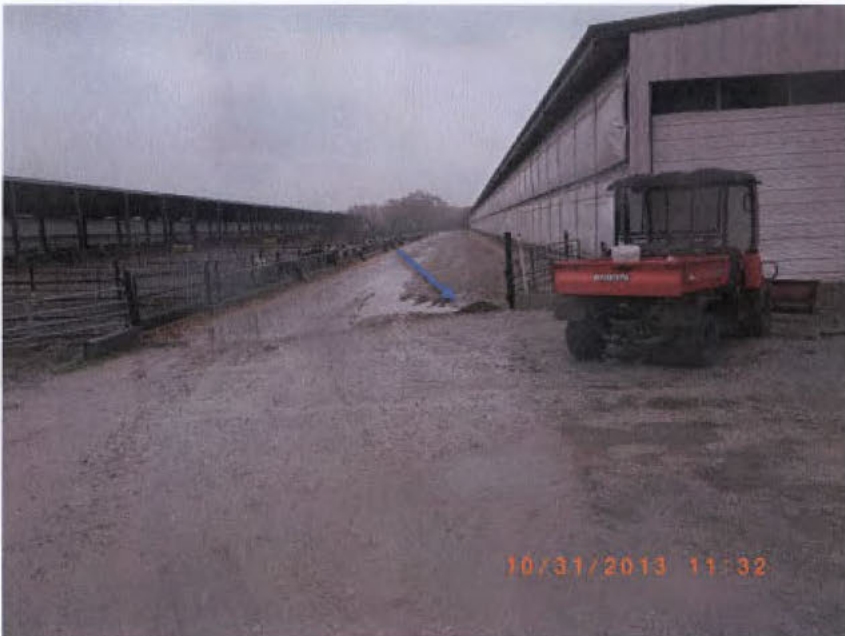
79: IMGP0601

Description: Between pen 3 (left) and pen 2 (right). Arrow points to manhole draining road.

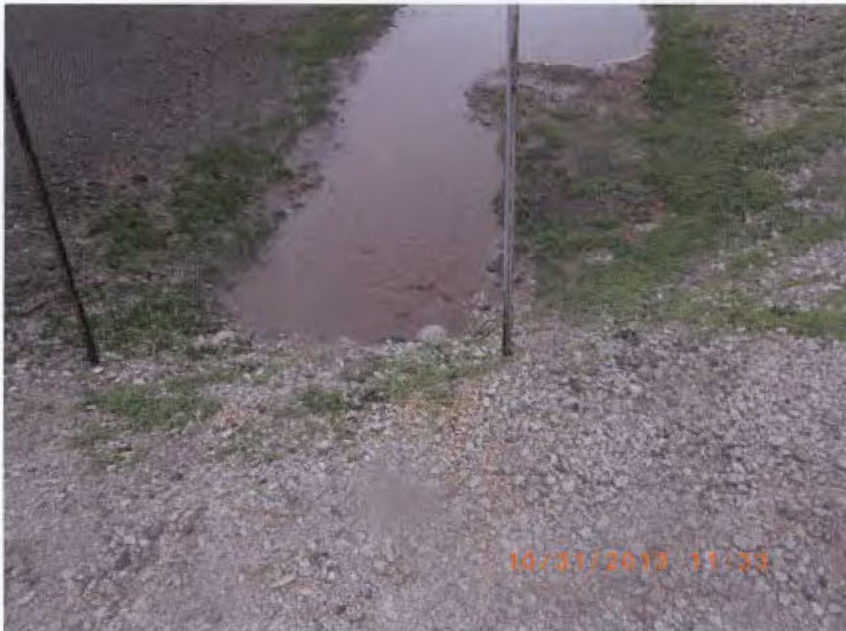
81: IMGP0603

Description: Runoff flowing south out of pipes under road between pen 3 and pen 2.

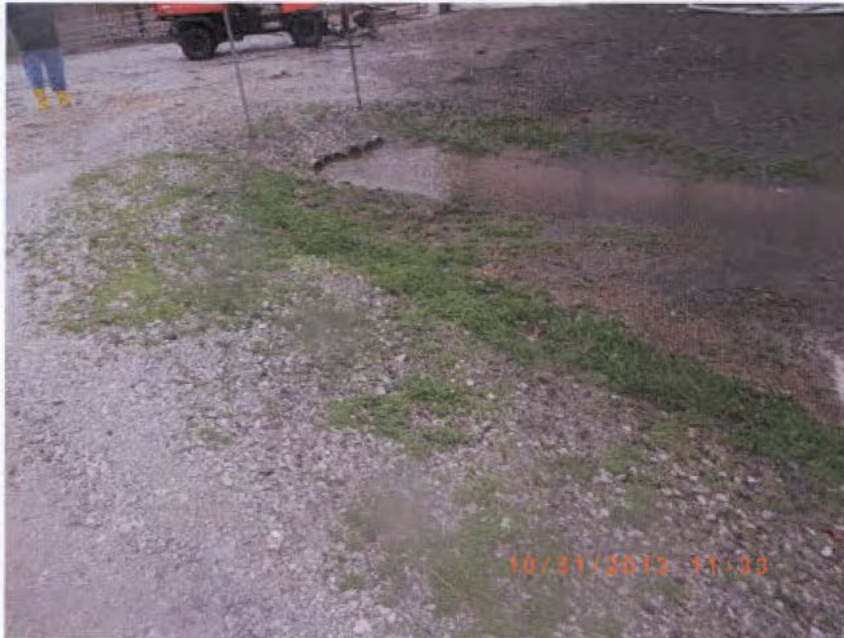
82: IMGP0604

Description: Runoff flowing south out of pipes under road between pen 3 and pen 2.

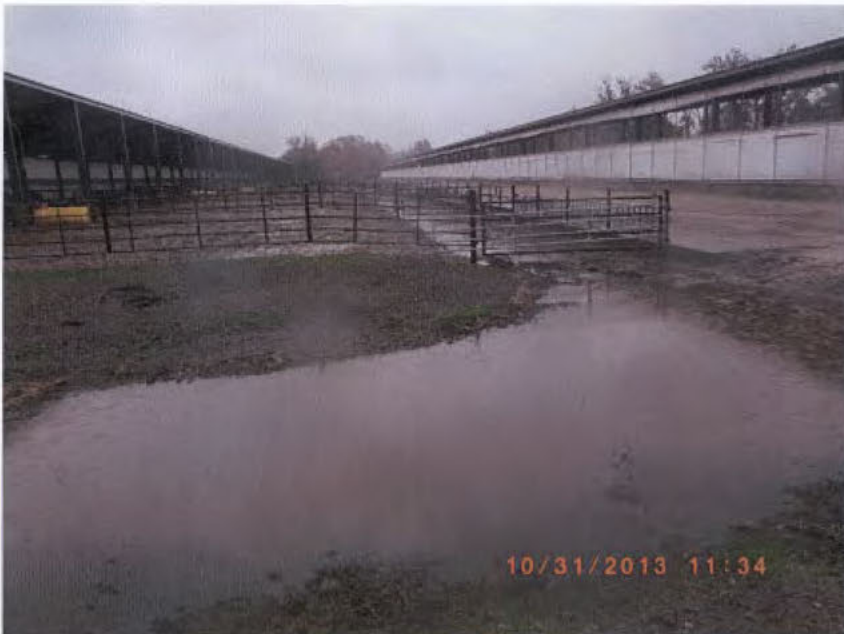
83: IMGP0605

Description: Runoff from pen 2 flowing into ditch on east side of central access road.

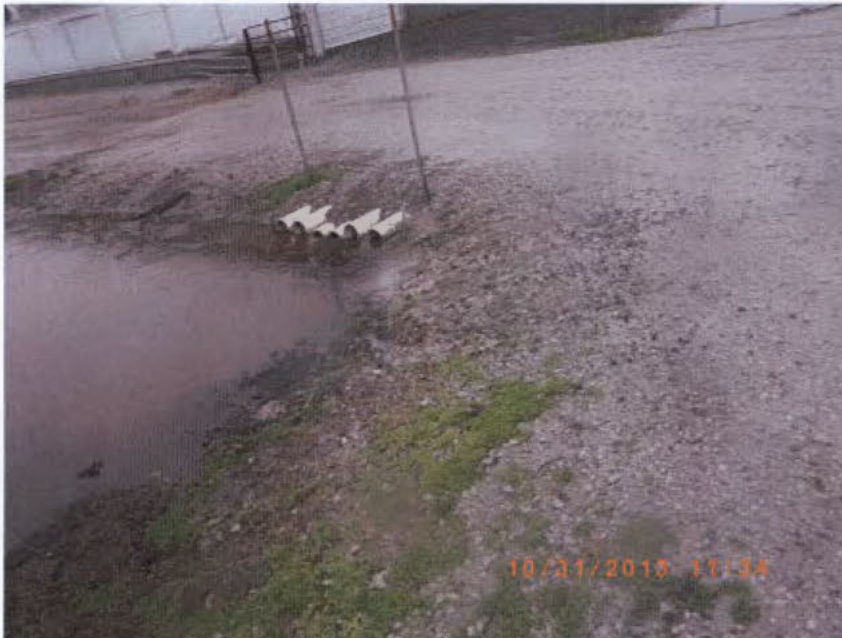
84: IMGP0606

Description: Runoff flowing into pipes under road between pen 2 and pen 1.

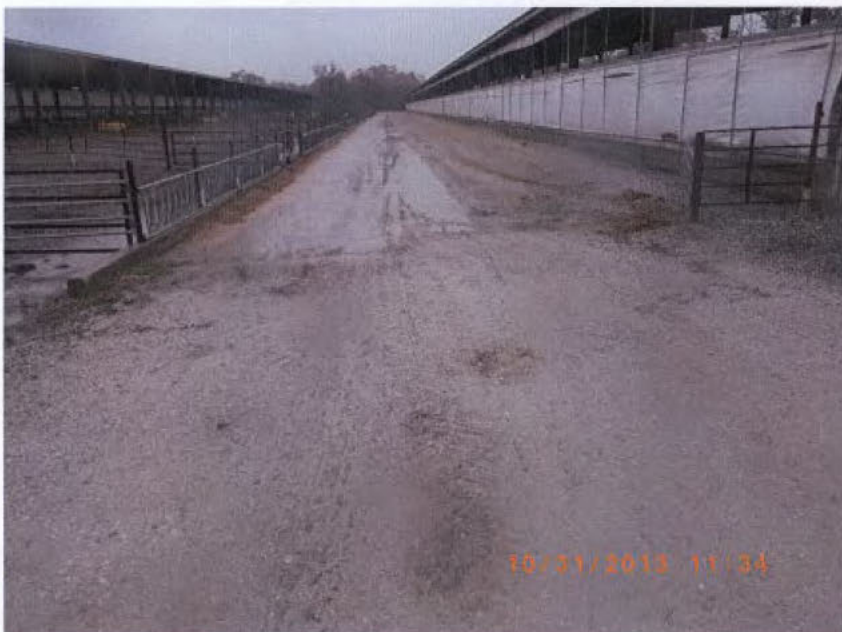
85: IMGP0607

Description: Road between pen 2 (left) and pen 1 (right).

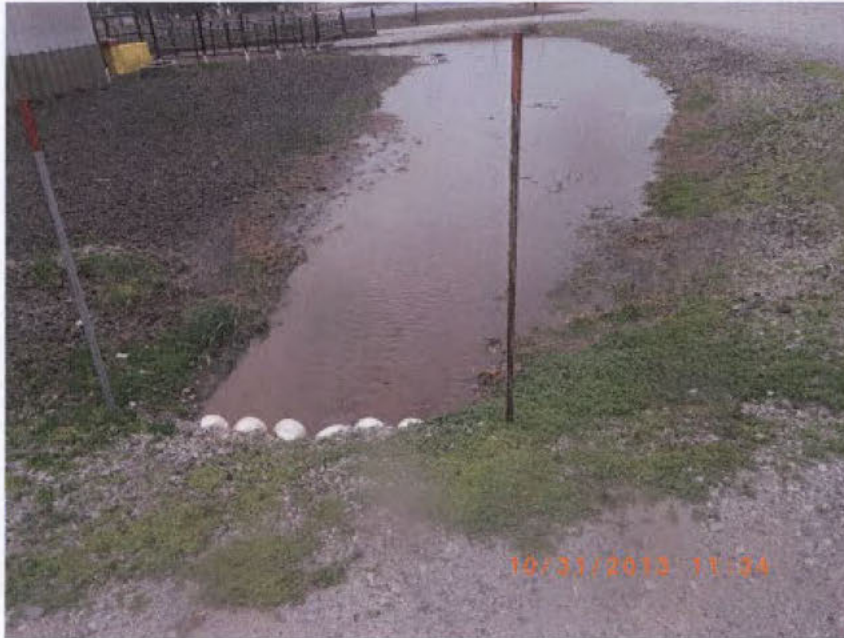
86: IMGP0608

Description: Flow out of pipes beneath road between pen 2 and pen 1.

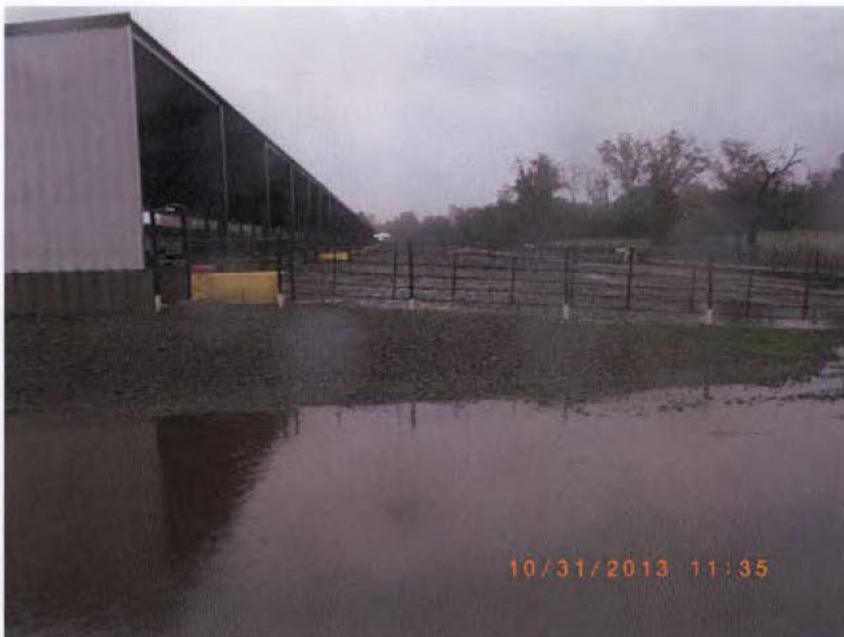
87: IMGP0609

Description: Runoff from pen 1 flowing into ditch on east side of central access road.

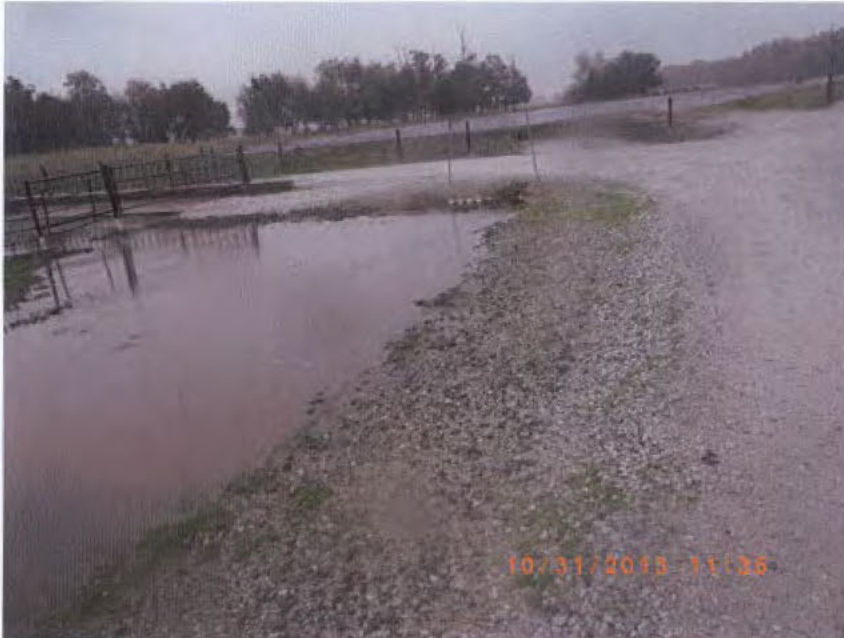
88: IMGP0610

Description: Flow in ditch on east side of central access road into pipes under road south of pen 1.

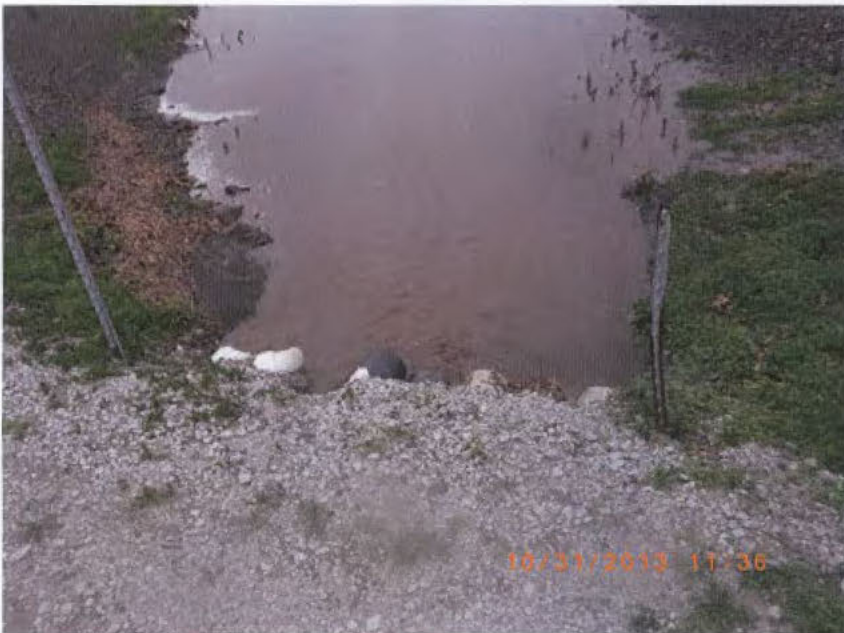
89: IMGP0611

Description: Flow out of pipes under road south of pen 1 in ditch on east side of central access road.

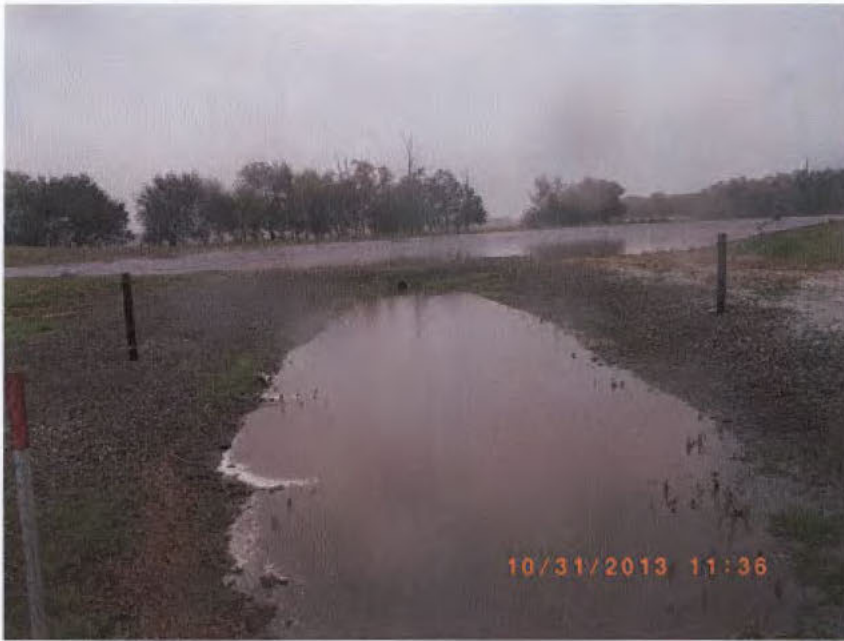
90: IMGP0612

Description: Ditch on east side of central access road flowing into pipe under berm of storage pond.

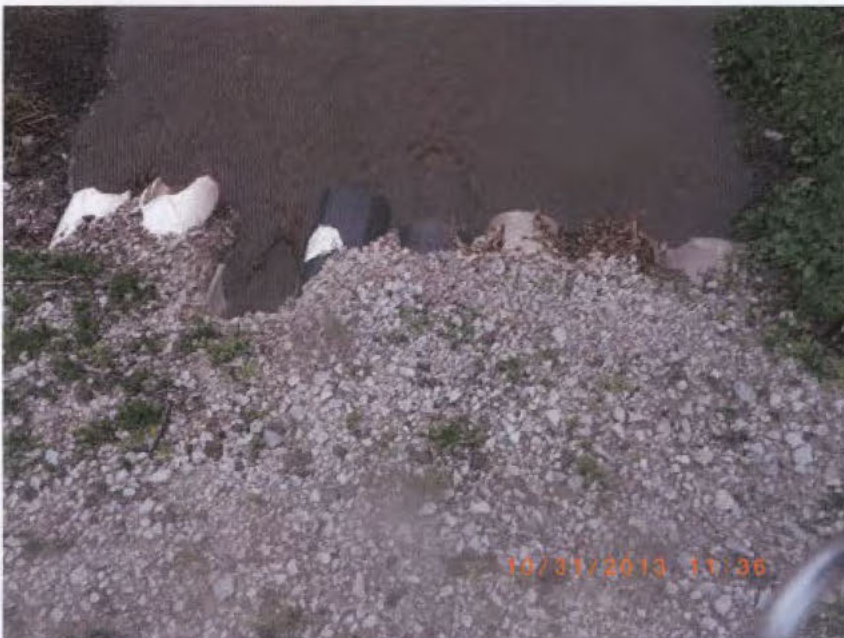
91: IMGP0613

Flow out of pipes under road south of pen 1 in ditch on east side of central access road.

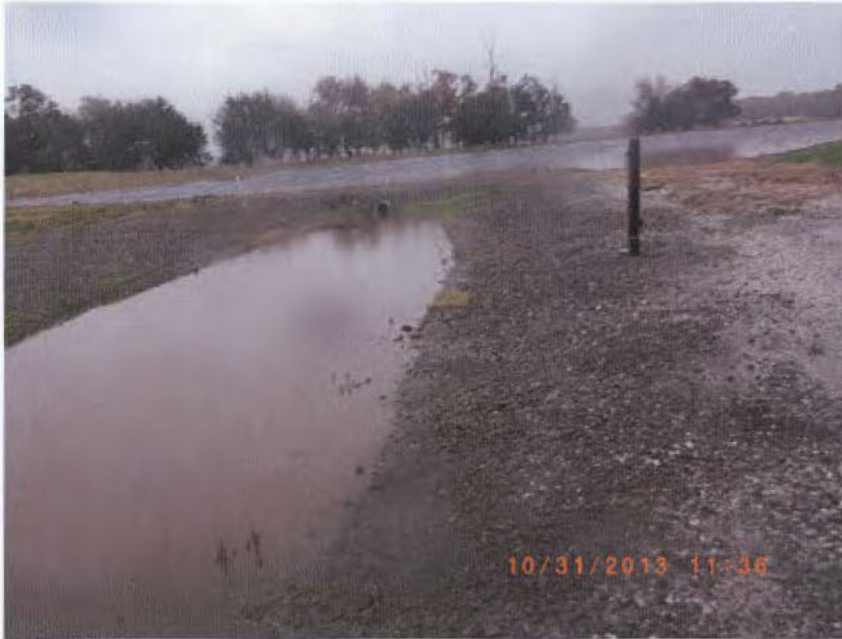
92: IMGP0614

The inspectors continued south and observed the liquid in the ditch on the east side of the main access road flowing into the storage pond (photos 92-100).

Description: Ditch on east side of central access road flowing into pipe under berm of storage pond.

Location: West of pen 1.

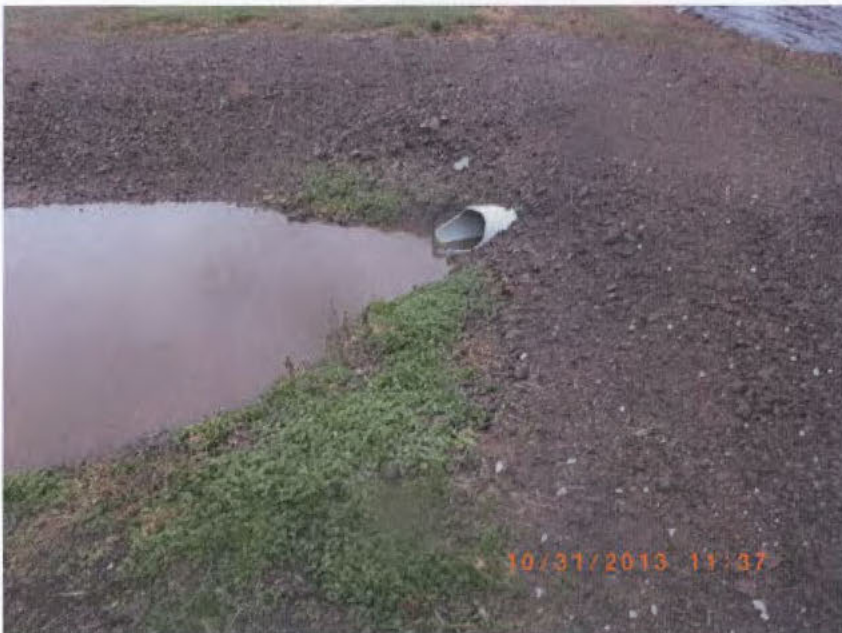
93: IMGP0615

Description: Ditch on east side of central access road flowing into pipe under berm of storage pond.

Location: Northwest corner of storage pond.

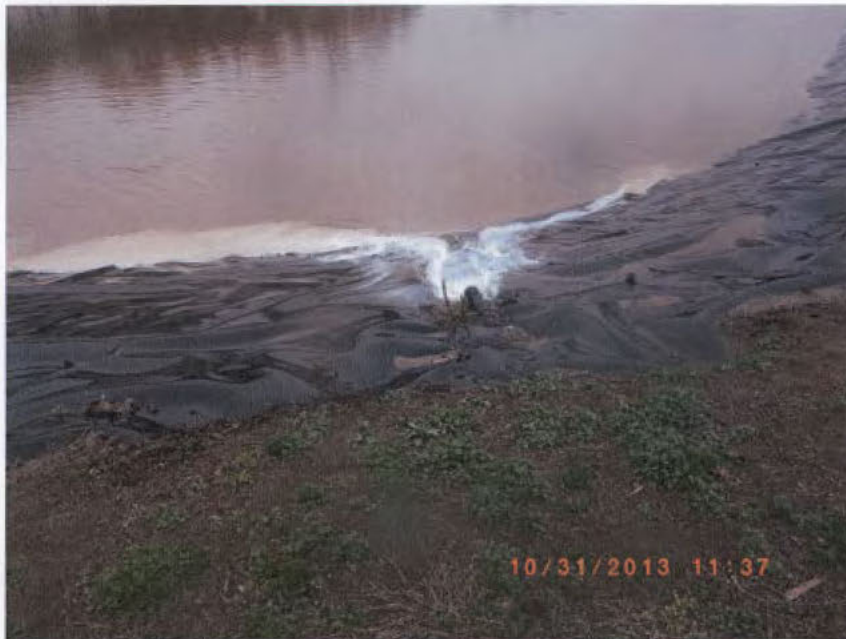
94: IMGP0616

Description: Outlet of pipe receiving flow from ditch on east side of central access road into storage pond.

Location: Northwest corner of storage pond.

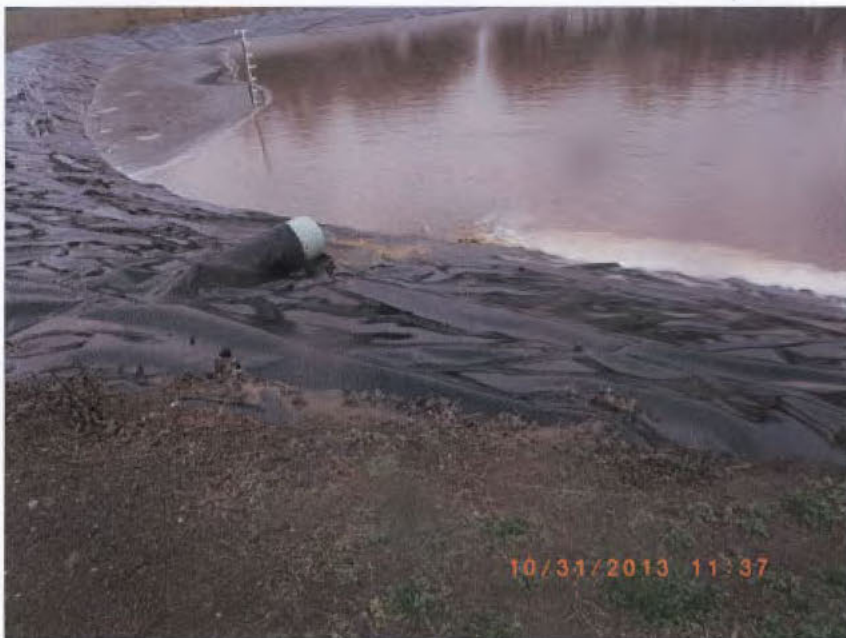
95: IMGP0617

Description: Outlet of pipe receiving flow from ditch on east side of central access road into storage pond.

Location: Northwest corner of storage pond.

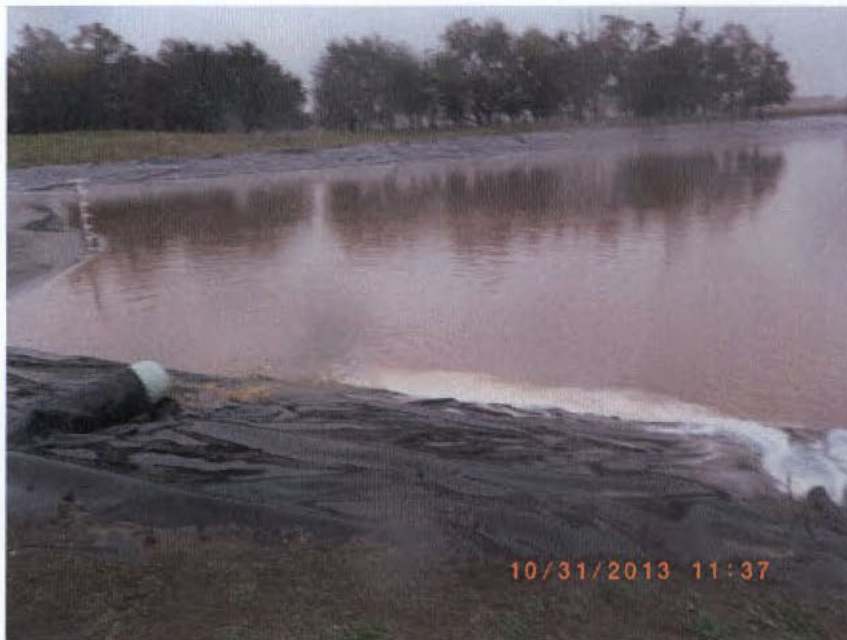
96: IMGP0618

Description: Outlet of pipe receiving flow from ditch on east side of central access road into storage pond.

Location: Northwest corner of storage pond.

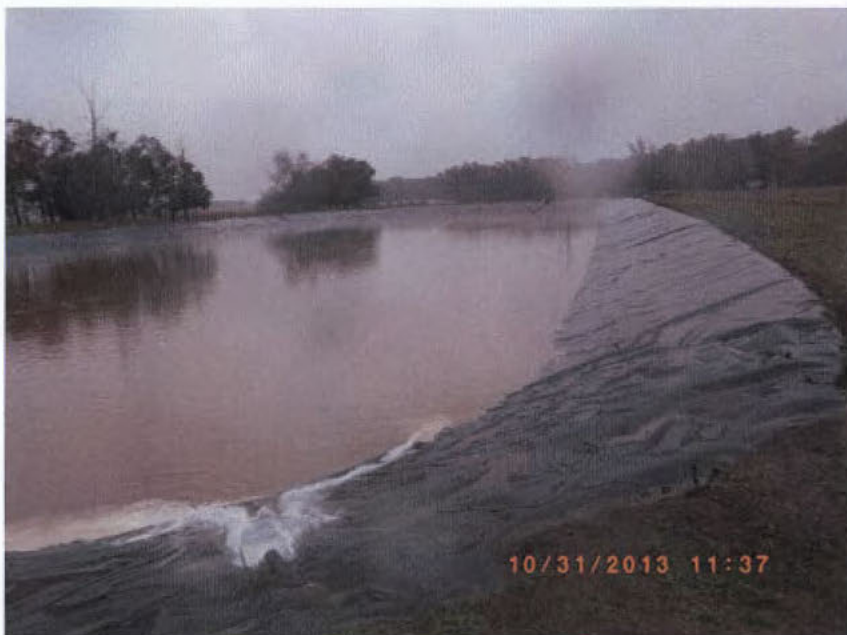
97: IMGP0619

Description: Outlet of pipe receiving flow from ditch on east side of central access road into storage pond.

Location: Northwest corner of storage pond.

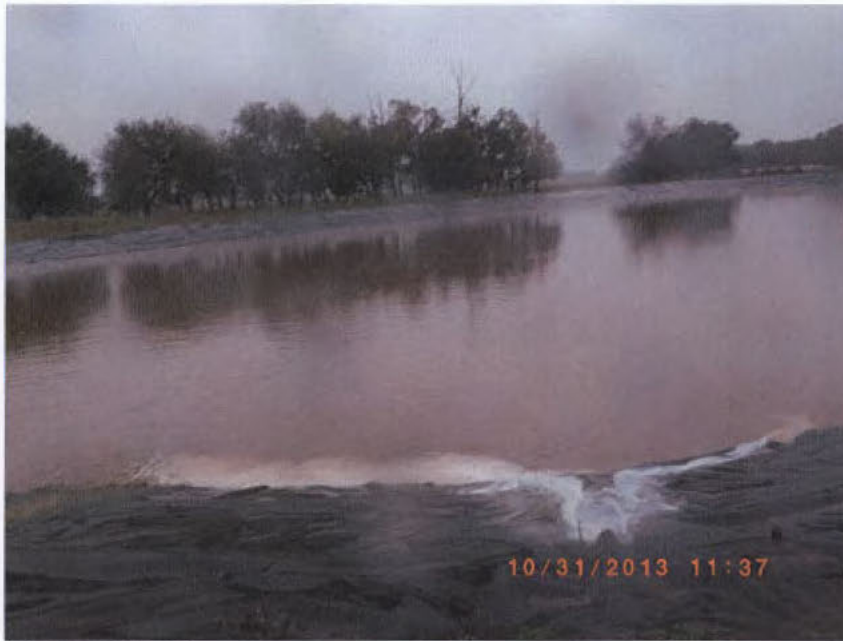
98: IMGP0620

Description: Outlet of pipe receiving flow from ditch on east side of central access road into storage pond.

Location: Northwest corner of storage pond.

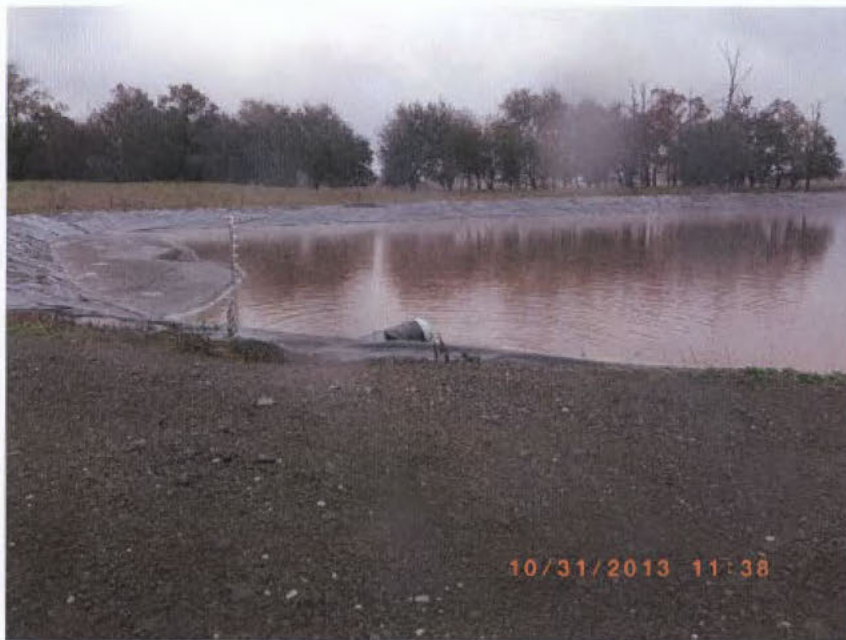
99: IMGP0621

Description: Outlet of pipe receiving flow from ditch on east side of central access road into storage pond.

Location: Northwest corner of storage pond.

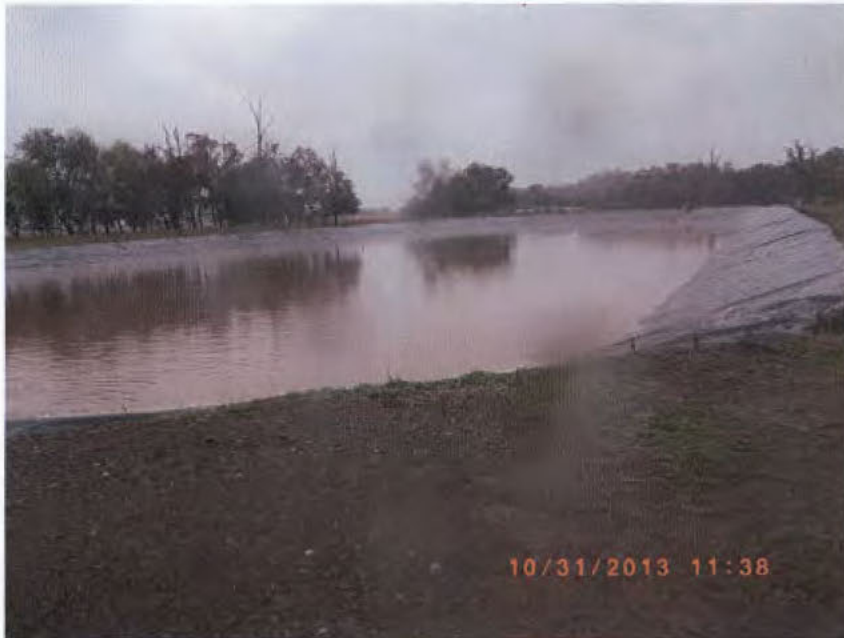
100: IMGP0622

Description: Storage pond.

Location: Northwest corner of storage pond.

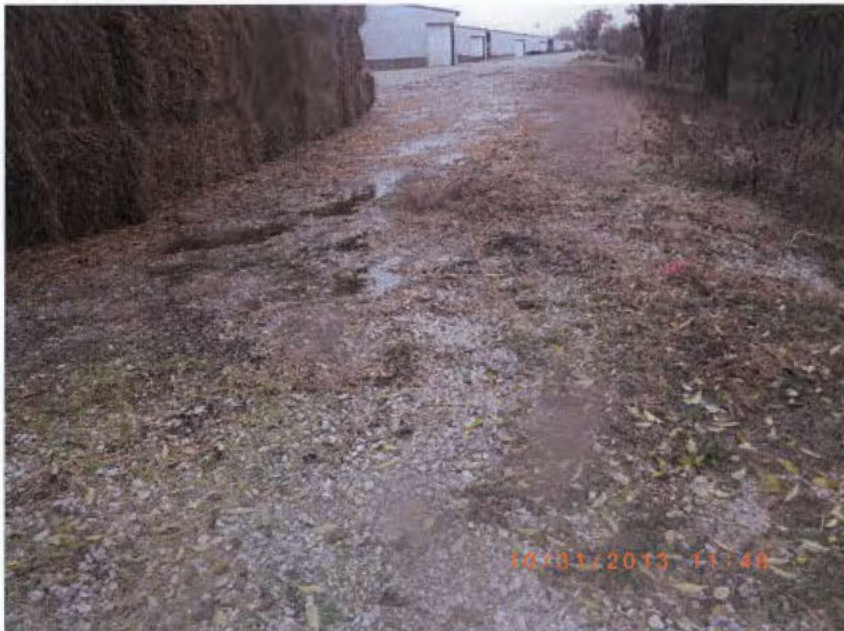
101: IMGP0623

The inspectors then walked east on the south side of pen 1 and observed a hay storage area. Runoff from the hay storage area appeared to flow to the east (photos 101-104). The inspectors continued walking north on the east side of the Pen Area and observed the calf loading area on the east side of Pen 5. Runoff from this area appeared to flow to the southeast (photos 105-107). The inspectors then walked north around the remainder of the Pen Area and returned the Office on the west side of the facility.

Description: Hay storage on southeast side of pen area. Note runoff from hay storage area flowing to east.

Location: Southeast corner of facility

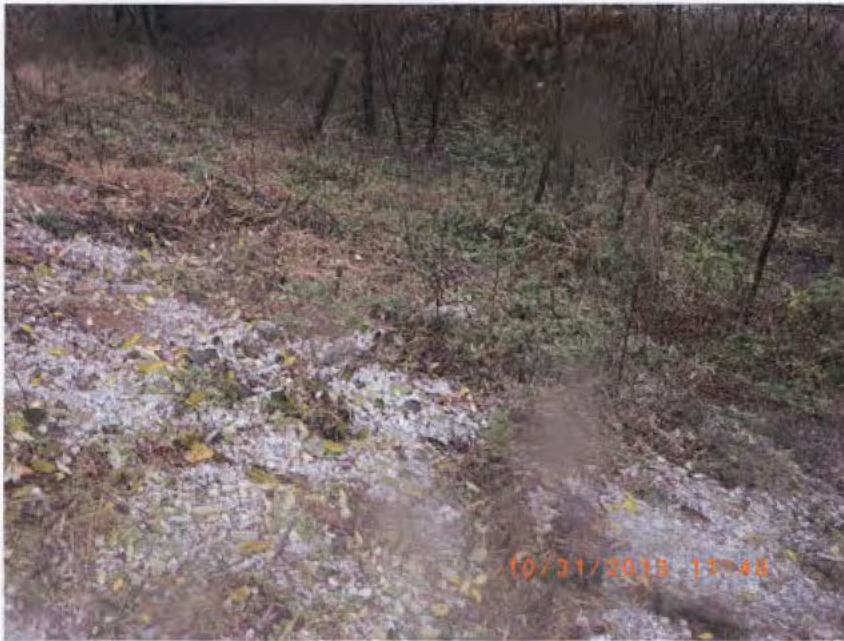
102: IMGP0624

Description: Area to which runoff from hay storage area flows.

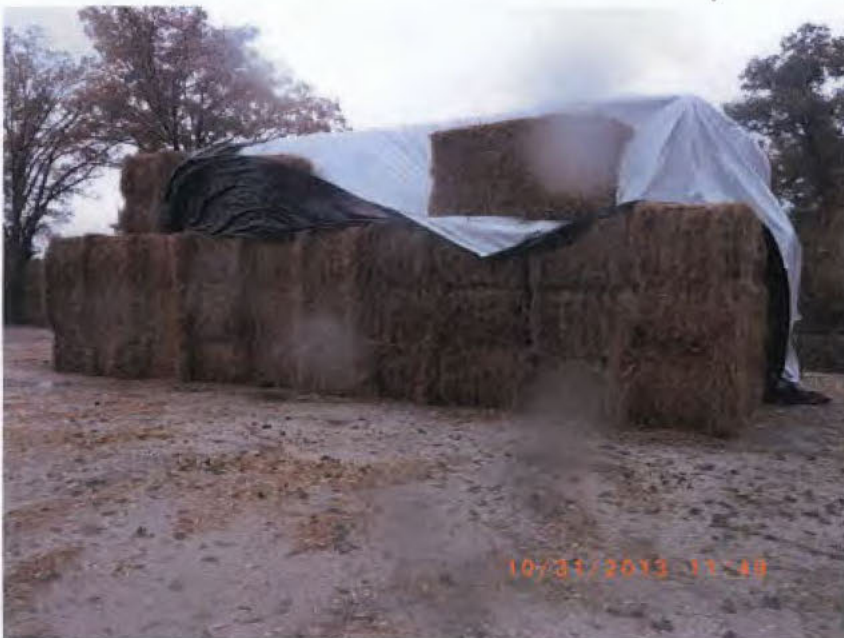
103: IMGP0625

Description: Hay storage on southeast side of pen area.

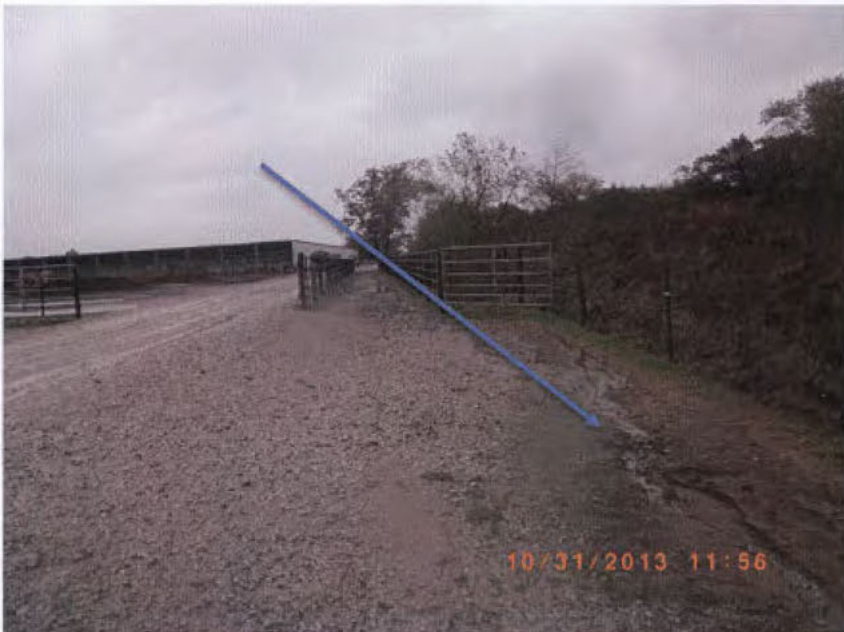
105: IMGP0627

Description: Calf loading area east of pen 5. Note runoff pathway (arrow).

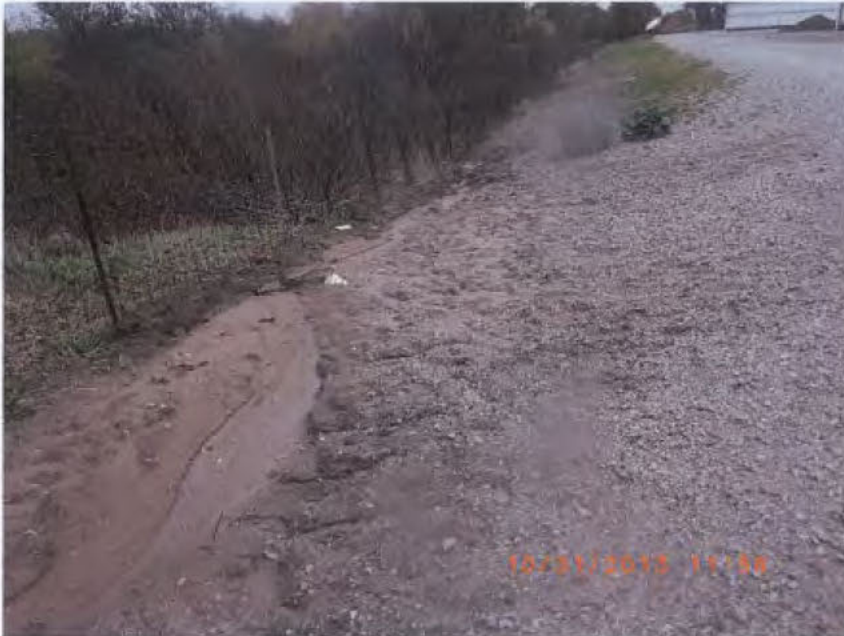
106: IMGP0628

Description: Runoff pathway from calf loading area to the southeast.

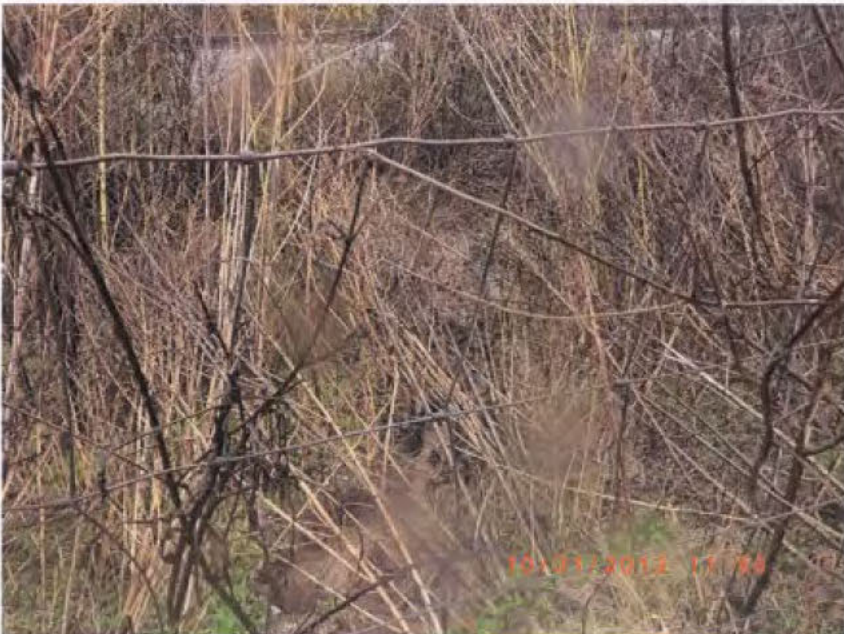
107: IMGP0629

Description: Area into which runoff pathway from calf loading area flows
